Converse Consultants

**Subject: RESPONSE TO CITY OF ROSEMEAD – GEOLOGICAL REPORT
REVIEW DATED SEPTEMBER 13, 2010 BY ECI**
Rosemead Park Aquatic Center
9155 E. Mission Drive
Rosemead, CA
Converse Project No. 10-31-284-01

Reference: "Geotechnical Study Report, Rosemead Park Aquatic Center, 9155 E. Mission Drive, Rosemead, California, Converse Project No. 10-31-284-01, dated September 3, 2010"

City of Rosemead Geological Report Review

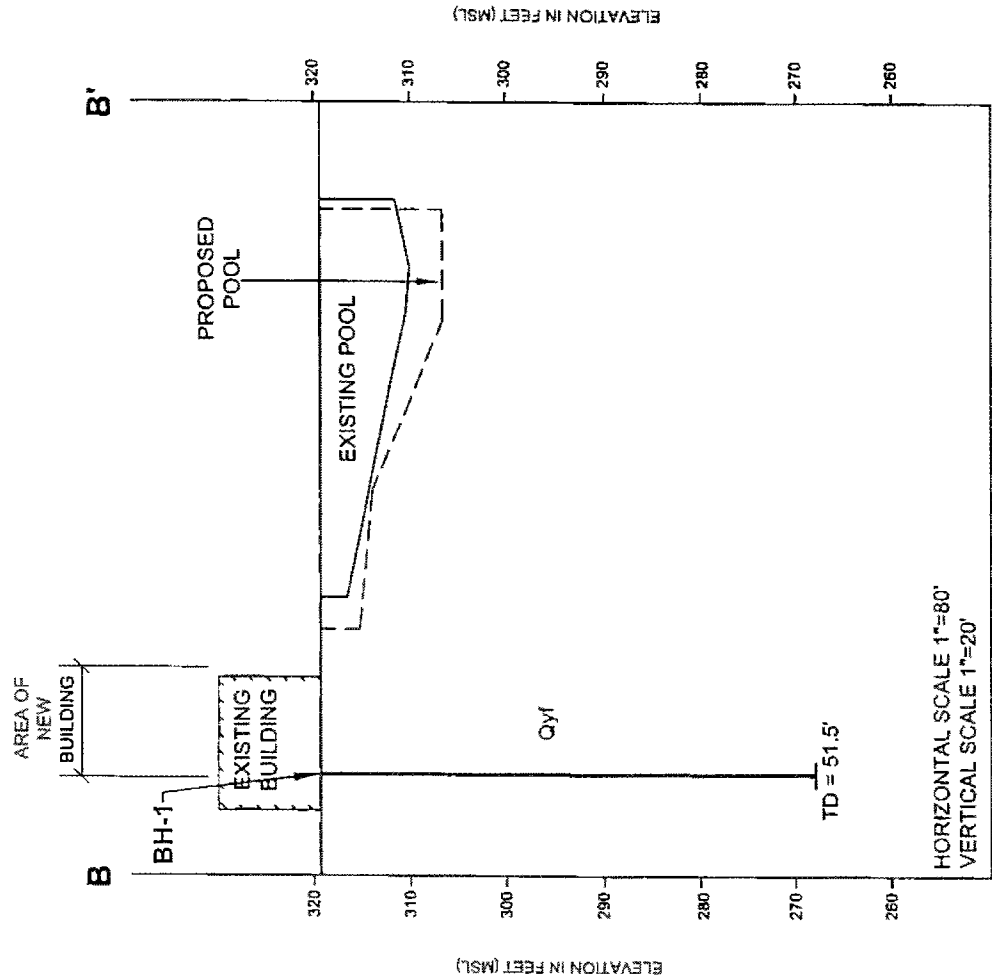
GEOLOGIC CROSS SECTION B-B'

Qyf = Alluvial Fan Deposits

Encl: Geotechnical Report Review, dated September 16, 2010
Drawing No. 2a, *Site Plan and Boring Location Map*
Drawing No. 2b, *Proposed Improvement Plan*
Drawing No. 3a, *Geotechnical Cross Section A-A'*
Drawing No. 3b, *Geotechnical Cross Section B-B'*

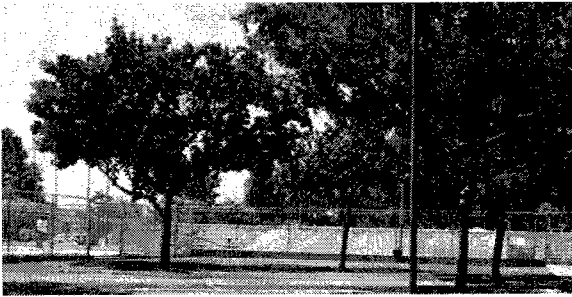
Test area viewed facing west

The future planting area on the east side of the aquatic center was evaluated. The area is currently covered with uniform, dark green turf.
